Lessons from Communication Problems that Nearly Jeopardized Development of Hardware-Software Support for a 1000-Device IoT Testbed

Mateusz Banaszek, Inga Rüb, Maciej Dębski, Agnieszka Paszkowska, Maciej Kisiel, Dawid Łazarczyk, Ewa Głogowska, Przemysław Gumienny, Cezary Siłuszyk, Piotr Ciołkosz, Jacek Łysiak, Wojciech Dubiel, Szymon Acedański, Przemysław Horban, Konrad Iwanicki
Faculty of Mathematics, Informatics and Mechanics
University of Warsaw

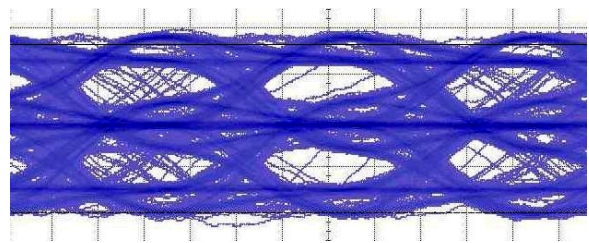
Finally, we decided to use an oscilloscope to examine electrical signals transmitted by Cherry devices over an Ethernet cable. Even first measurements explained why they could not establish a connection: it was clearly visible from the eye diagram that the signal was heavily distorted (see Fig. 2). A corresponding eye diagram of a connection with the evaluation board looked significantly cleaner (see Fig. 3). It indicated that the problem was related not to software but to hardware. Moreover, since that Cherry device and that evaluation board employed identical embedded computers, we learned that the problem laid in the PCB which connected the embedded computer with Ethernet ports within Cherry

At that point we were behind our initial schedule, and we still knew only that while Cherry devices did not work properly, the original evaluation boards did. So there must have been a difference. Not having any better idea how to find it, we compared both devices by just carefully looking at them: there it was! Eight resistors were not present on the evaluation board but they were mounted on Cherry device's PCB. Removing them from our design solved the problem! After just desoldering them Cherry devices were establishing Ethernet connection immediately, even when they were connected via the *'very bad cable'*. Measurements with an oscilloscope also confirmed that not mounting those eight resistors significantly improved quality of Ethernet signals.

Figure 2. Oscilloscope measurements: Ethernet communication with Cherry device

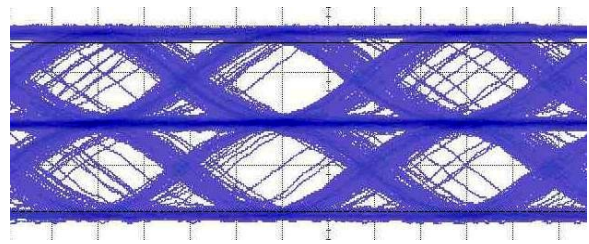
Figure 3. Oscilloscope measurements: Ethernet communication with the evaluation board

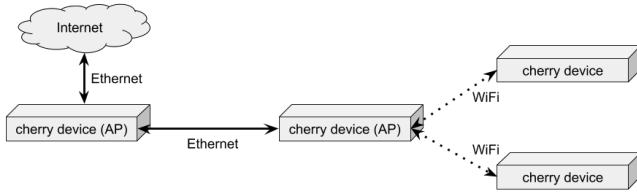
Figure 5. The setup for the integration test

Successful preliminary tests encouraged us to perform an integration test with a more complex setup: four prototype Cherry devices connected as presented in Figure 5. Our goal was to verify if such a miniature testbed was able to revive after possible network failures, e.g. caused by a suddenly disconnected Ethernet cable or cutting off the access point. Before we even got started, a disruptive issue appeared, which was much more troublesome than any of the potential problems being the subject of the trial.

firmed quantitatively: the packet loss was abnormally high, moreover, it soared with the increasing number of devices connected to the AP and occurred for all our devices. With additional experimental setups we compared performance of Cherry devices with an off-the-shelf router and a laptop. Collected results (see Table 1) led to a conclusion that our devices were not handling WiFi connections properly, regardless of whether they played the role of the AP or not.

Any embedded computer being the AP was, by default, functioning in 8-BSSID mode. This means it was in fact owning 8 consecutive MAC addresses (including the address manually set by us – the only address we were aware of since we put just one wireless network in Cherry device's configuration). Some of those addresses were assigned by us to other devices (we used consecutive numbers for IDs and, thereby, consecutive MAC addresses for other devices), what resulted in double MAC addresses in the network – the direct reason for the packet loss. To fix the problem it was enough to ensure that no two MAC addresses that we set were within the range of 8 from each other. From that point onward we were using MAC addresses ended with 0 (separated by 15 MAC addresses between) so that they were not doubled by any additional MAC addresses used in 8-BSSID mode.
