Lessons from Communication Problems that Nearly Jeopardized Development of Hardware-Software Support for a 1000-Device IoT Testbed

Abstract

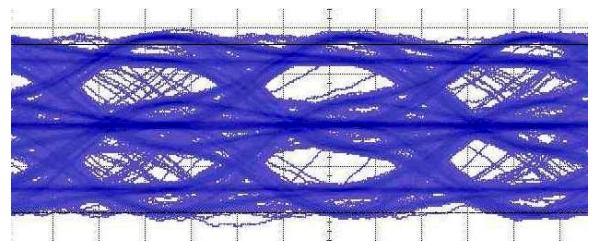
Figure 2. Oscilloscope measurements: Ethernet communication with Cherry device

Finally, we decided to use an oscilloscope to examine electrical signals transmitted by Cherry devices over an Ethernet cable. Even first measurements explained why they could not establish a connection: it was clearly visible from the eye diagram that the signal was heavily distorted (see Fig. 2). A corresponding eye diagram of a connection with the evaluation board looked significantly cleaner (see Fig. 3). It indicated that the problem was related not to software but to hardware. Moreover, since that Cherry device and that evaluation board employed identical embedded computers, we learned that the problem laid in the PCB which connected the embedded computer with Ethernet ports within Cherry

At that point we were behind our initial schedule, and we still knew only that while Cherry devices did not work properly, the original evaluation boards did. So there must have been a difference. Not having any better idea how to find it, we compared both devices by just carefully looking at them: there it was! Eight resistors were not present on the evaluation board but they were mounted on Cherry device's PCB. Removing them from our design solved the problem! After just desoldering them Cherry devices were establishing Ethernet connection immediately, even when they were connected via the '*very bad cable*'. Measurements with an oscilloscope also confirmed that not mounting those eight resistors significantly improved quality of Ethernet signals.

If you are an author of a design, make sure that you follow typical conventions and indicate clearly all non-standard solutions. Try to also minimize a possibility of any misunderstanding, e.g. if you cannot entirely remove an obsolete component from your design, at least do not provide its parameters. When using a technical documentation question each and every detail that seems negligible but its meaning is unclear, even if it is just two additional letters. Then, to project a timeline of a design process, plan some additional time for debugging problems which will highly probably occur even if you are following all standard good practices.
